# **DISTRICT INFRASTRUCTURE ASSESSMENT REPORT**

## **POITRAS EAST COMMUNITY DEVELOPMENT DISTRICT**

**APRIL 30, 2026**

**McINTOSH ASSOCIATES, an LJA COMPANY  
1950 SUMMIT PARK DRIVE, SUITE 600  
ORLANDO, FL 32810**

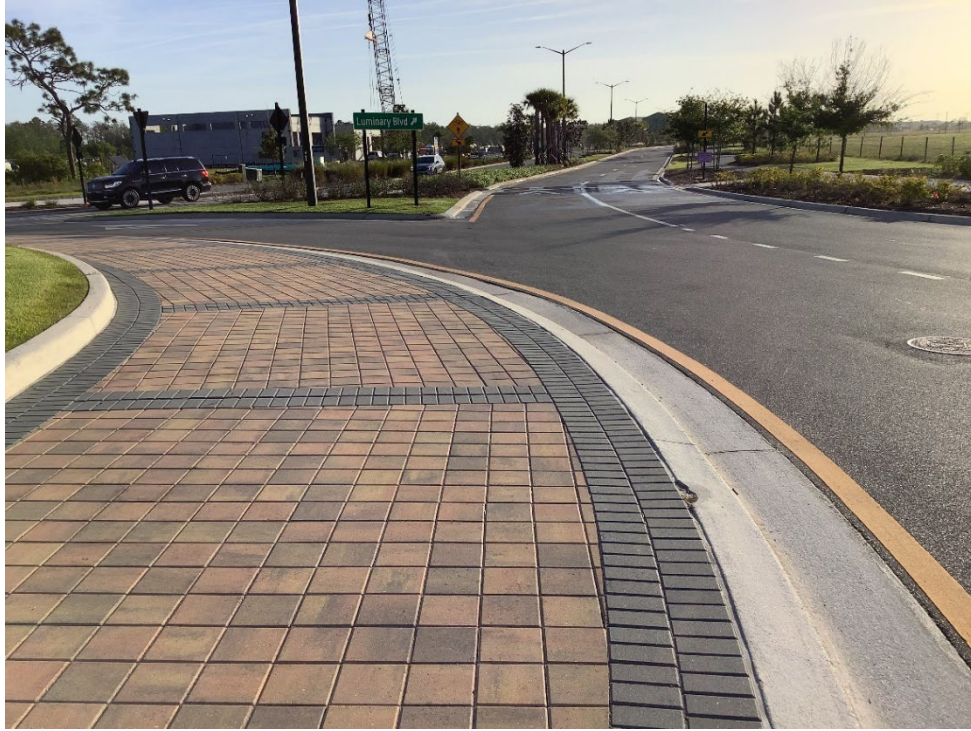
**Photo 1 - Damage to Concrete Curb Along Truck Apron (No Observed Changes)  
(Refer to Prior Photo 1 – 2025 Assessment)**

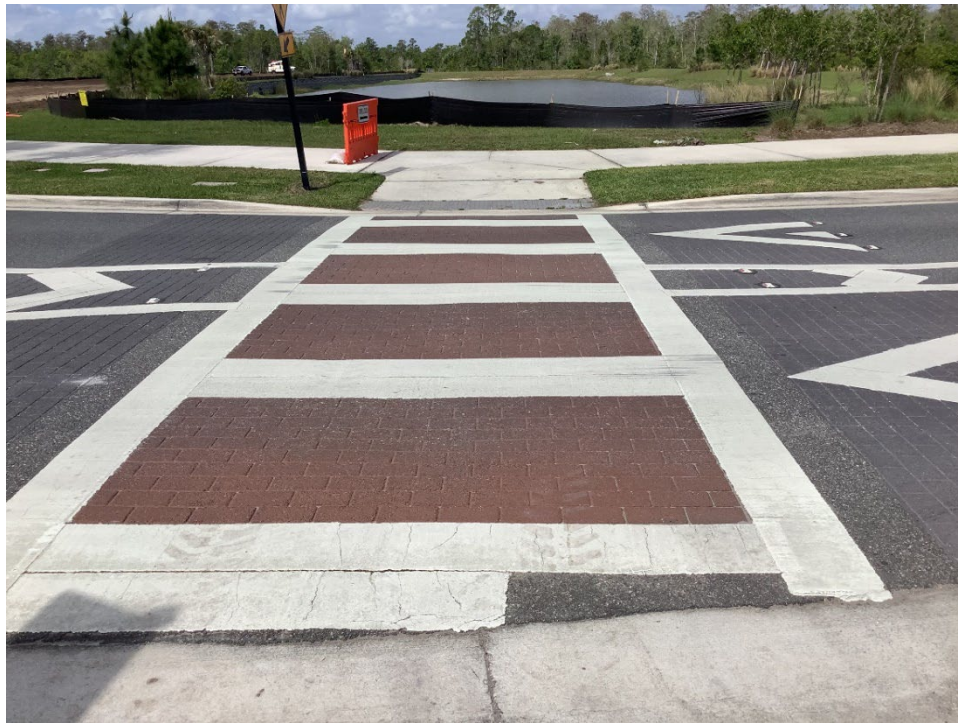
**Photo 2 - Deterioration of Thermoplastic and Worn Coloration (No Observed Changes)  
(Refer to Prior Photo 4 – 2025 Assessment)**

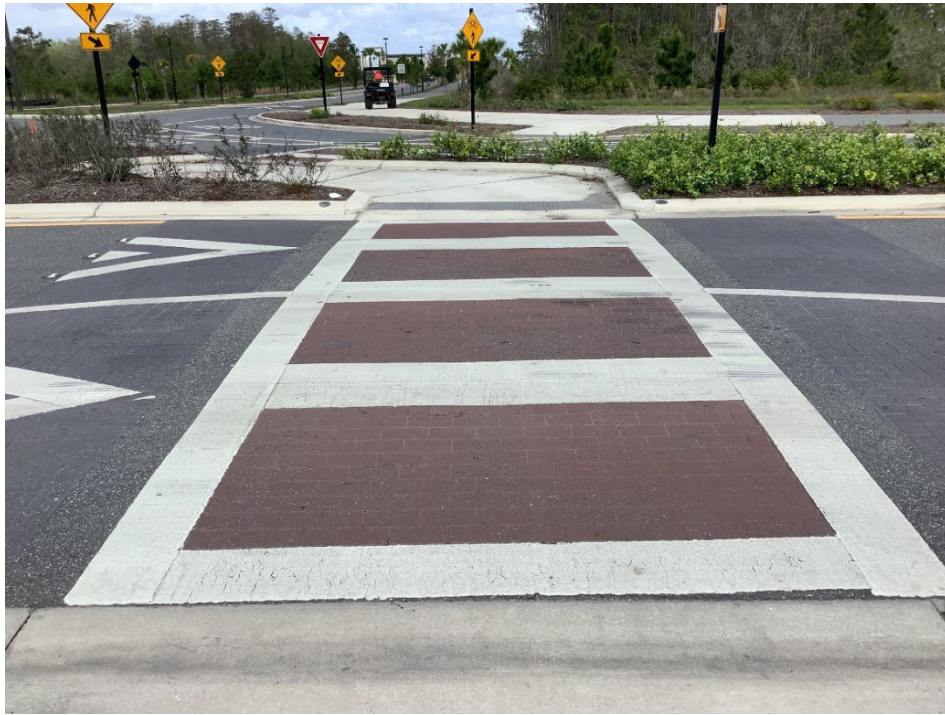
**Photo 3 - Deterioration of Thermoplastic and Worn Coloration (No Observed Changes)  
(Refer to Prior Photo 5 – 2025 Assessment)**

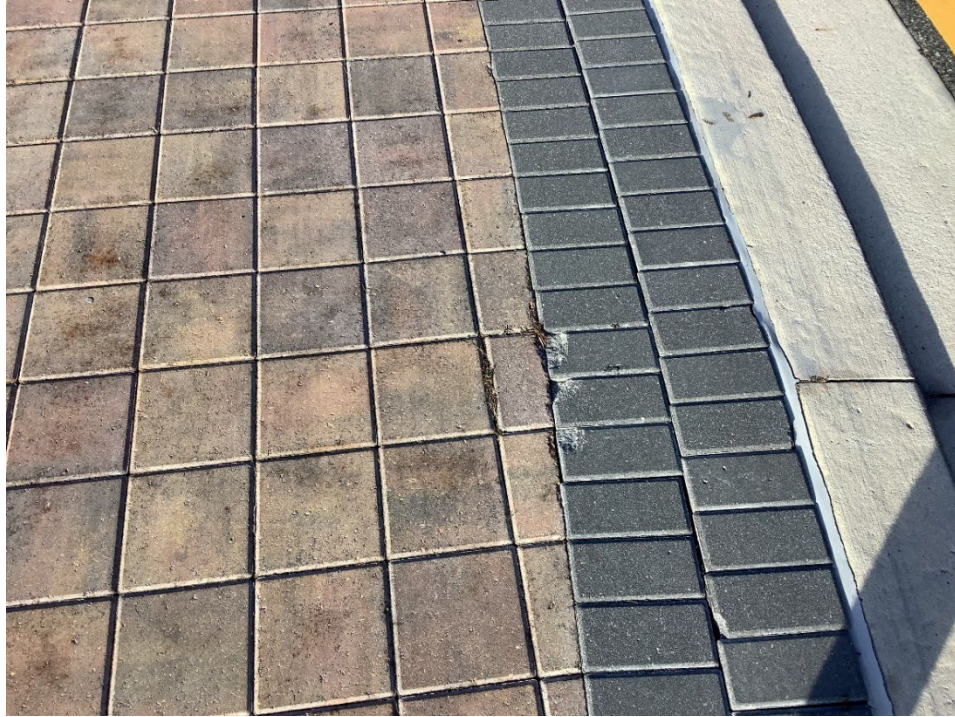
**Photo 4 - Broken Concrete Pavers on Truck Apron (No Observed Changes)  
(Refer to Prior Photo 6 – 2025 Assessment)**

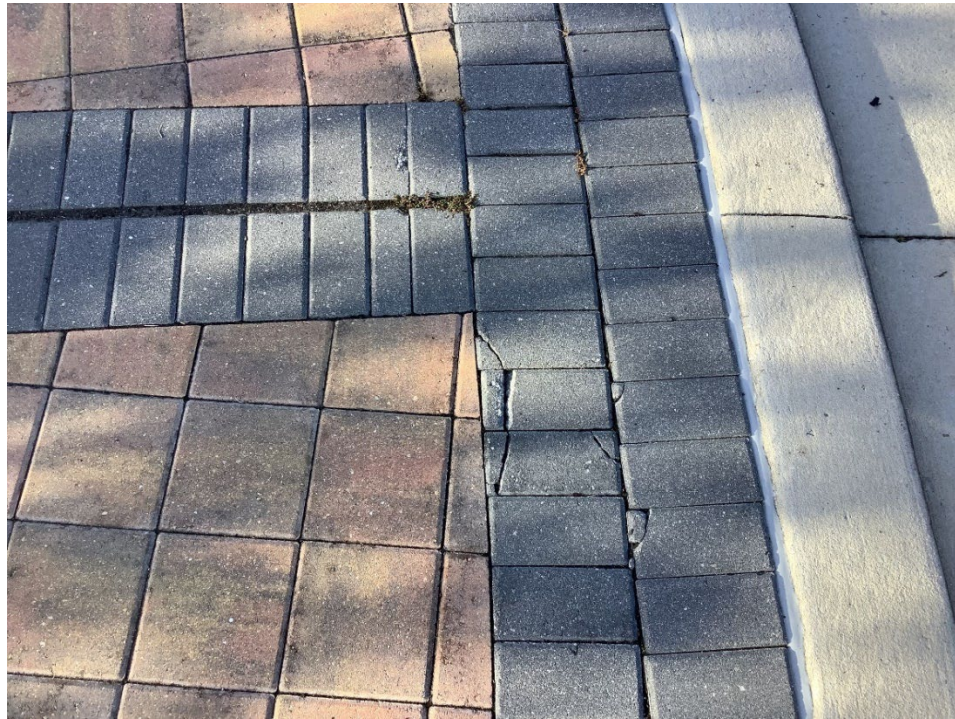
**Photo 5 - Broken Concrete Pavers on Truck Apron (Increased Damage Observed)  
(Refer to Prior Photo 8 – 2025 Assessment)**

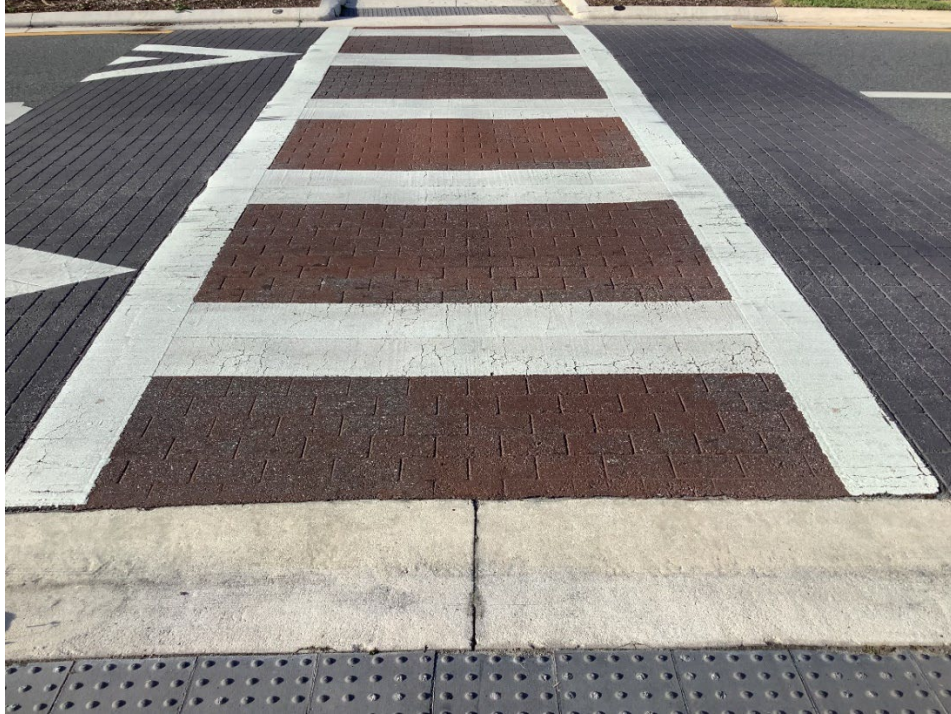
**Photo 6 - Deteriorating Thermoplastic and Worn Coloration (No Observed Changes)  
(Refer to Prior Photo 11 – 2025 Assessment)**

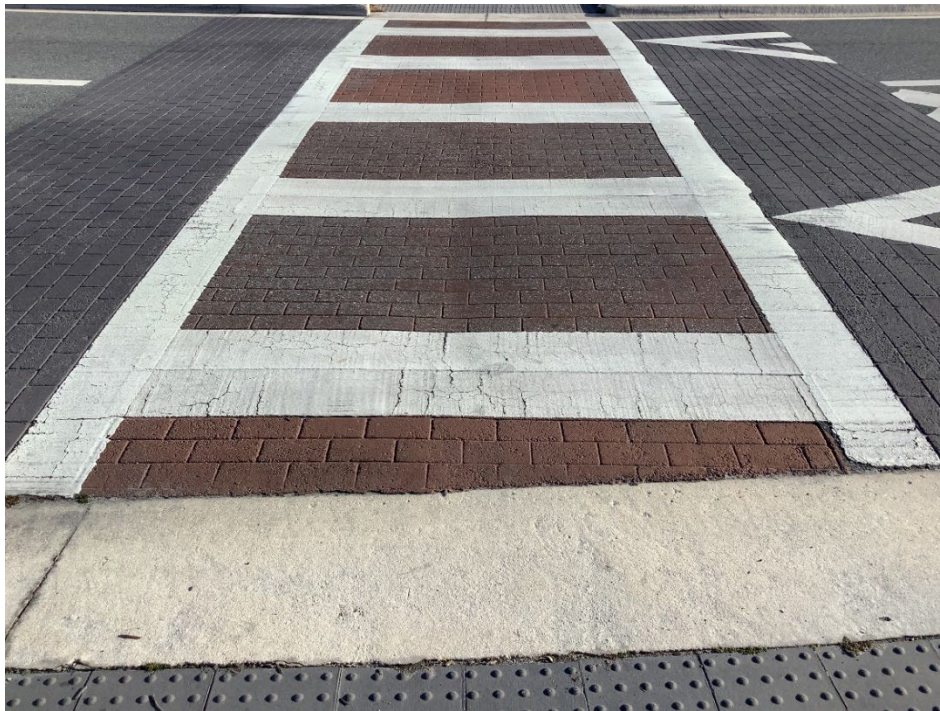
**Photo 7  
Deteriorating Thermoplastic and Worn Coloration (Further Deterioration Observed)  
(Refer to Prior Photo 13 – 2025 Assessment)**

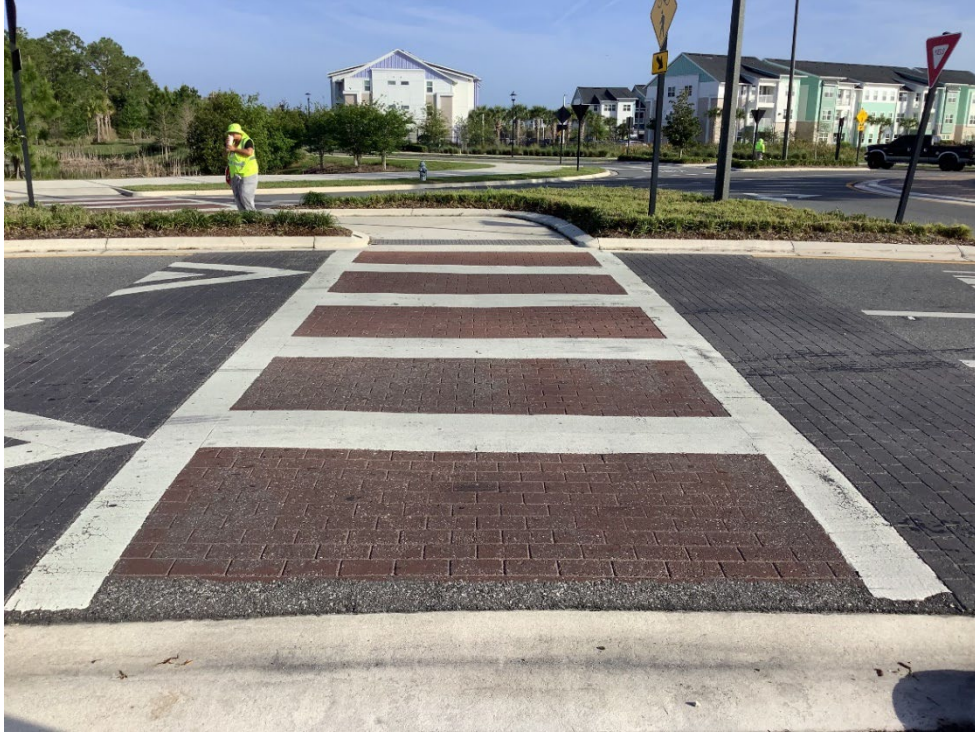
**Photo 8 - Deteriorating Thermoplastic and Worn Coloration (No Observed Changes)**  
(Refer to Prior Photo 14 – 2025 Assessment)

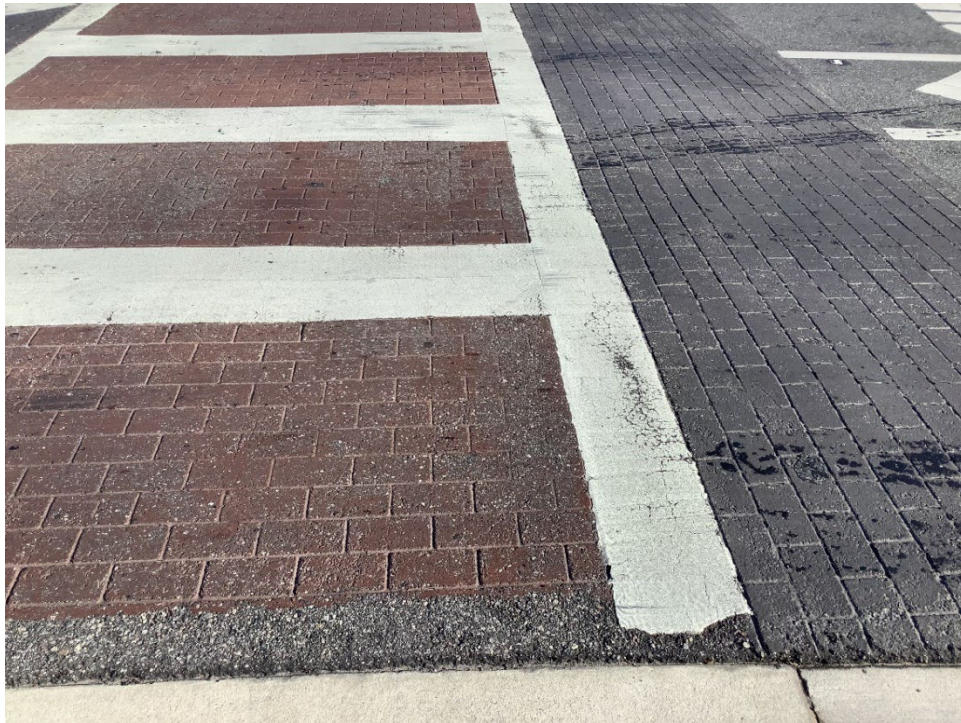
**Photo 9 - Deteriorating Thermoplastic and Worn Coloration (No Observed Changes)**  
(Refer to Prior Photo 15 – 2025 Assessment)

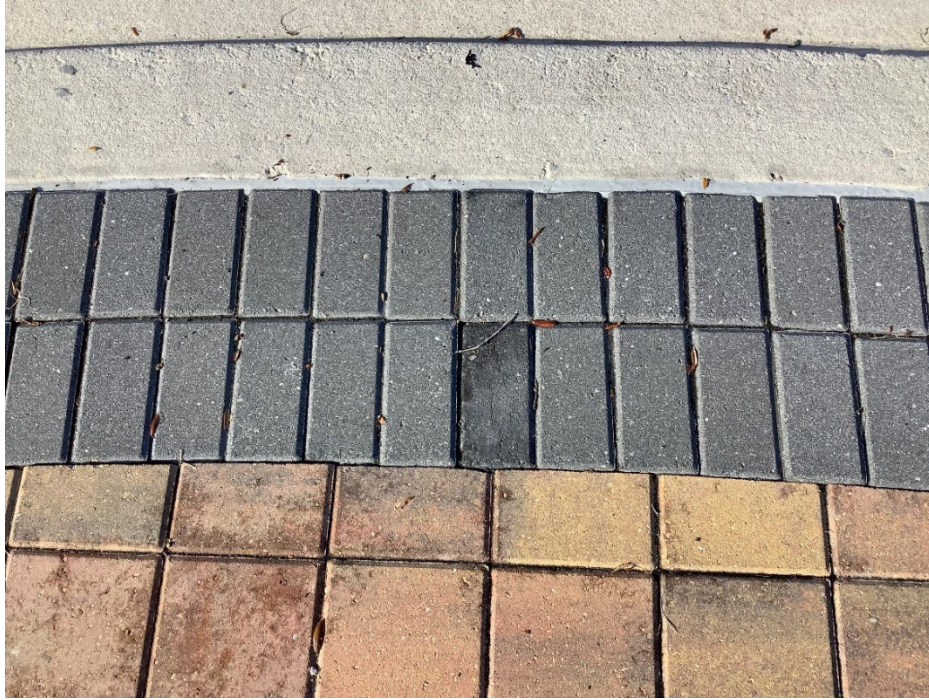
**Photo 10 - Uneven Concrete Pavers on Truck Apron (No Observed Changes)  
(Refer to Prior Photo 18 – 2025 Assessment)**

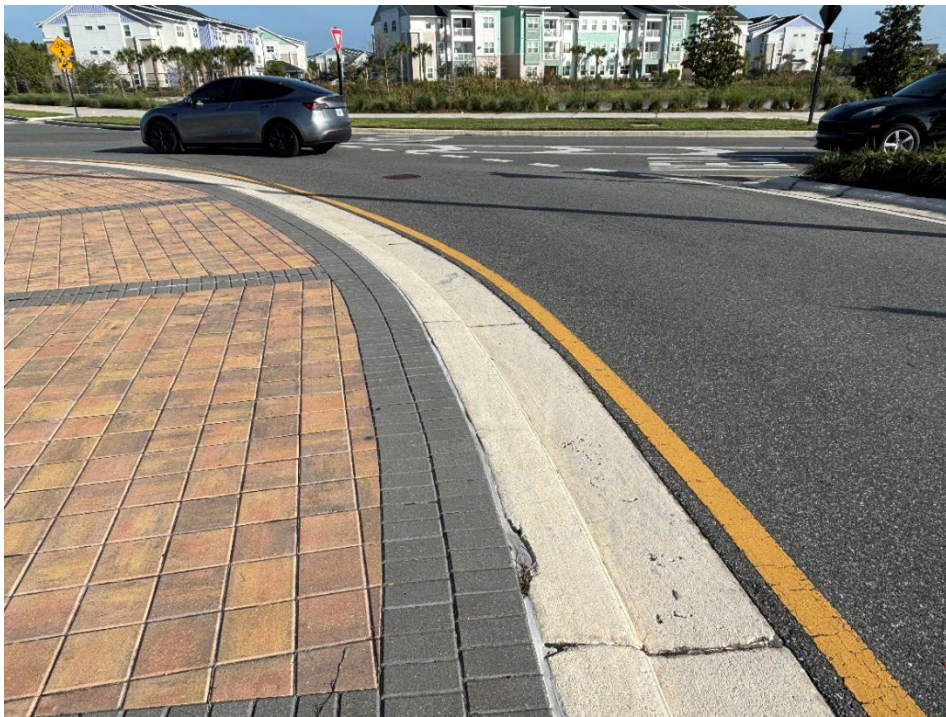
**Photo 10.1 - Damage to Concrete Curb Along Truck Apron  
(New Photo – 2026 Assessment)**

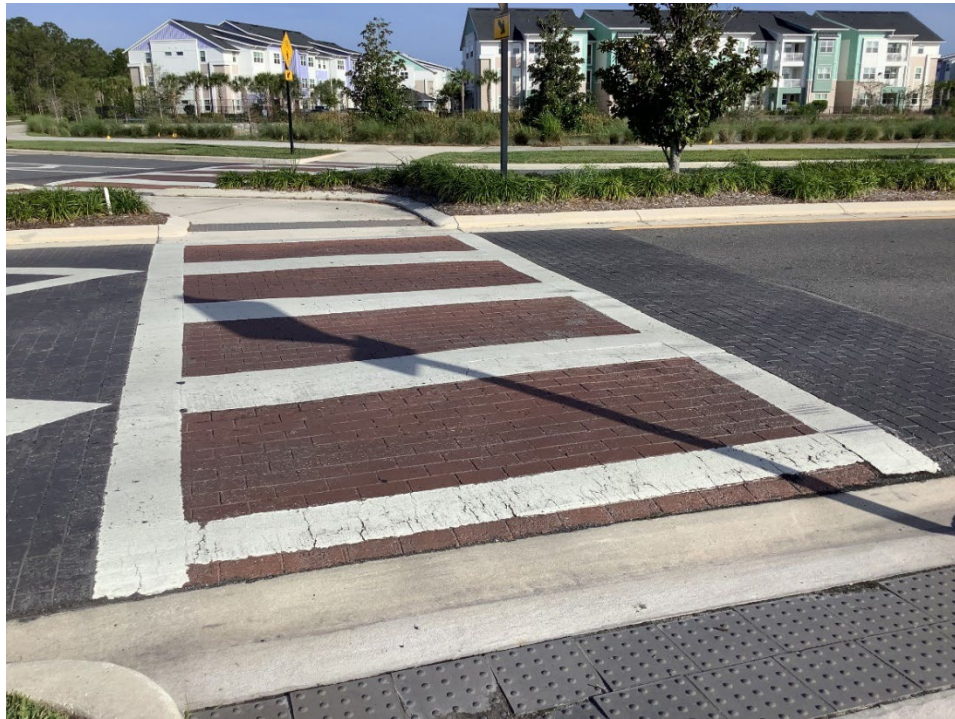
**Photo 11**  
**Deteriorating Thermoplastic and Worn Coloration (Further Deterioration Observed)**  
**(Refer to Prior Photo 21 – 2025 Assessment)**

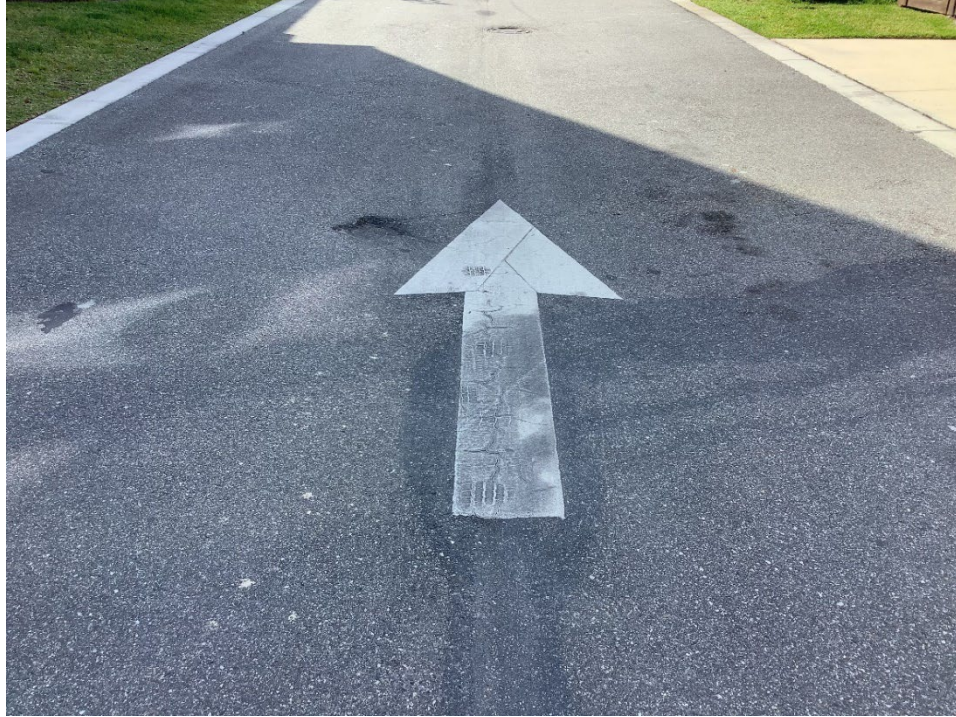
**Photo 12 - Laggett Alley – Asphalt Damage (No Observed Changes)  
(Refer to Prior Photo 26 – 2025 Assessment)**

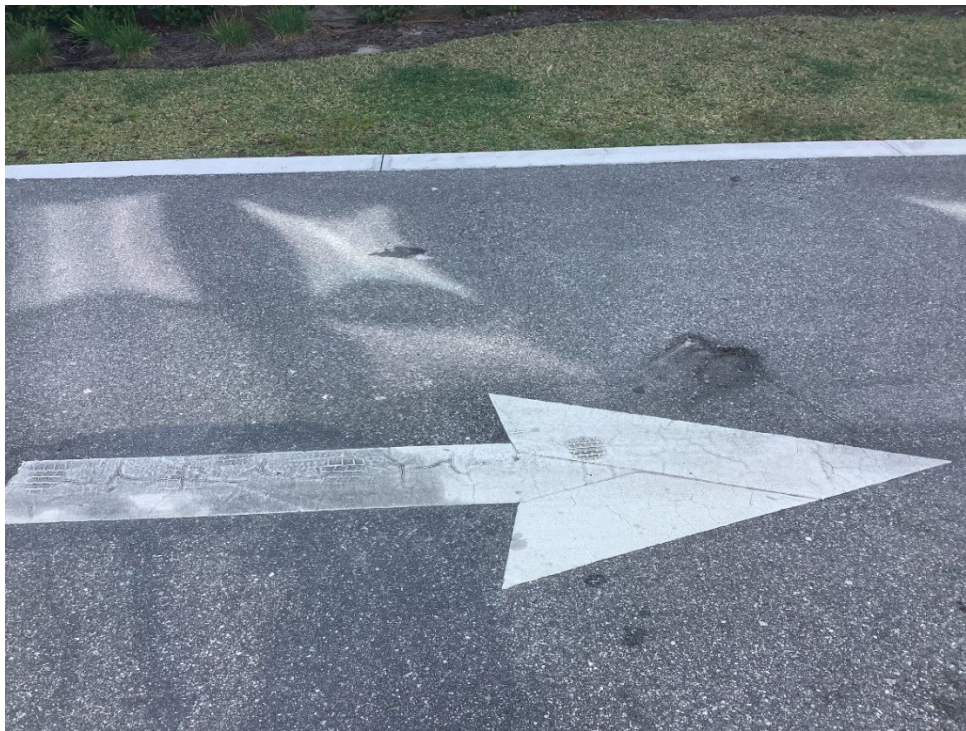
**Photo 13- Laggett Alley – Asphalt Damage (No Observed Changes)  
(Refer to Prior Photo 27 – 2025 Assessment)**

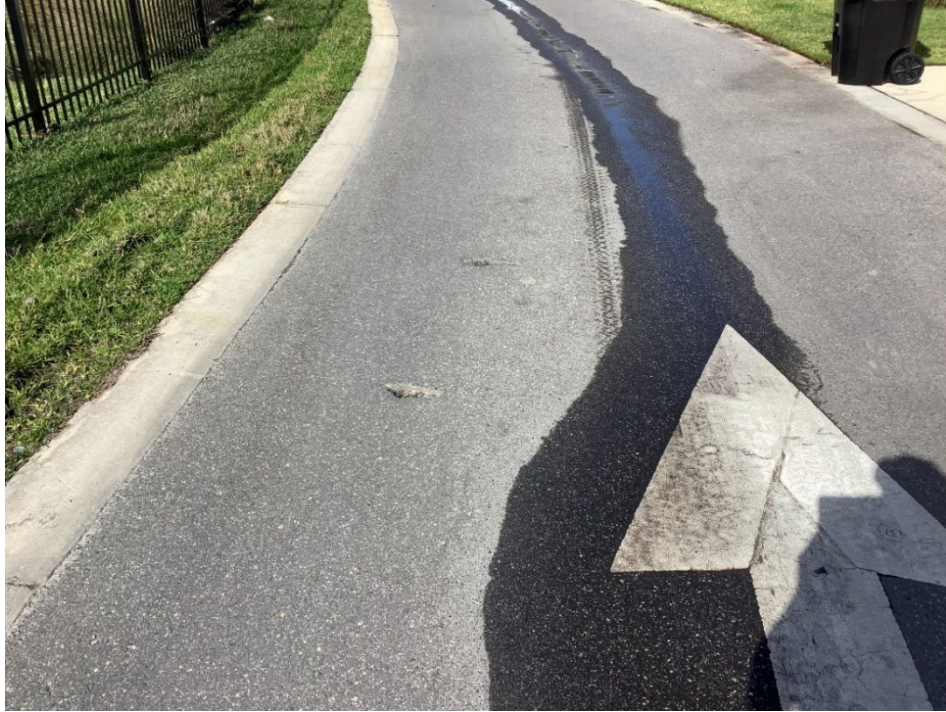
**Photo 14 - Laggett Alley – Asphalt Damage (No Observed Changes)  
(Refer to Prior Photo 28 – 2025 Assessment)**

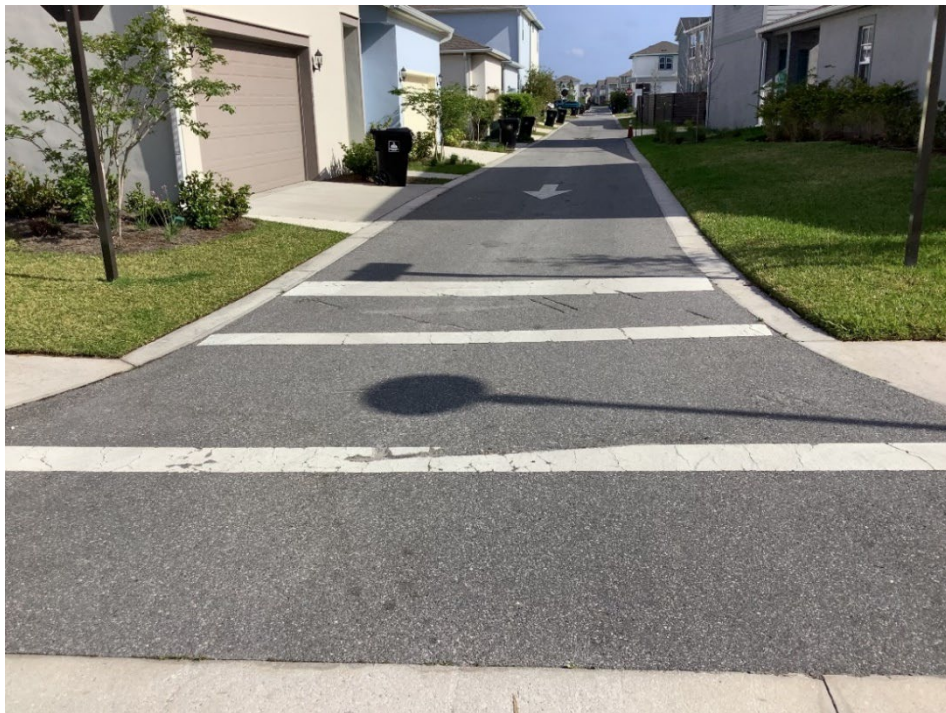
**Photo 15 - Marconi Alley – Deterioration of Thermoplastic  
and Gouged Asphalt (No Observed Changes)  
(Refer to Prior Photo 30 – 2025 Assessment)**

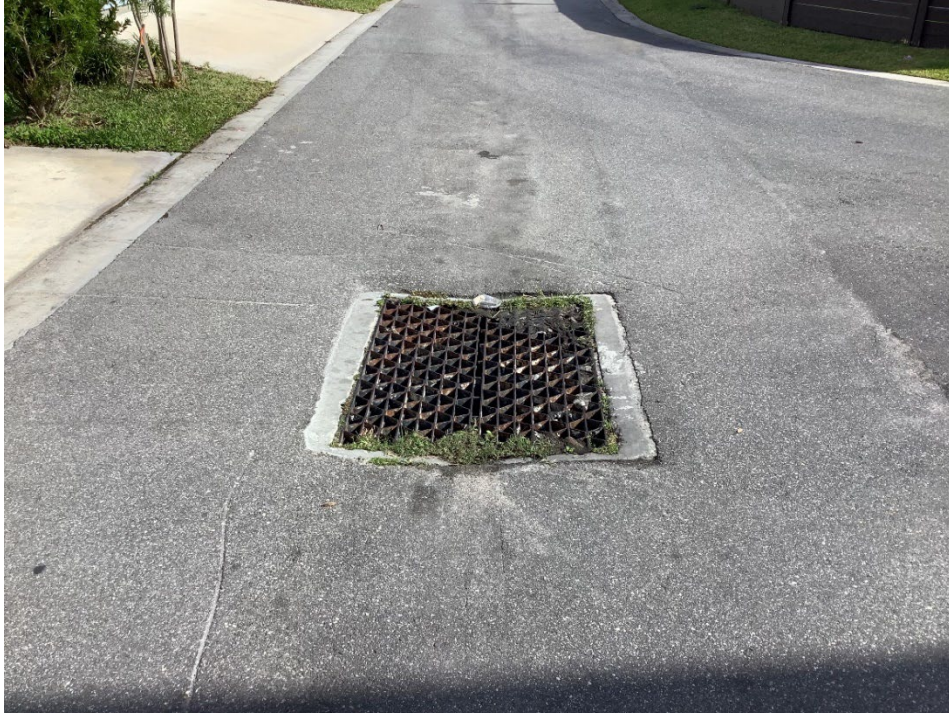
**Photo 16 - Bragg Alley – Scarred Asphalt (No Observed Changes)  
(Refer to Prior Photo 31 – 2025 Assessment)**

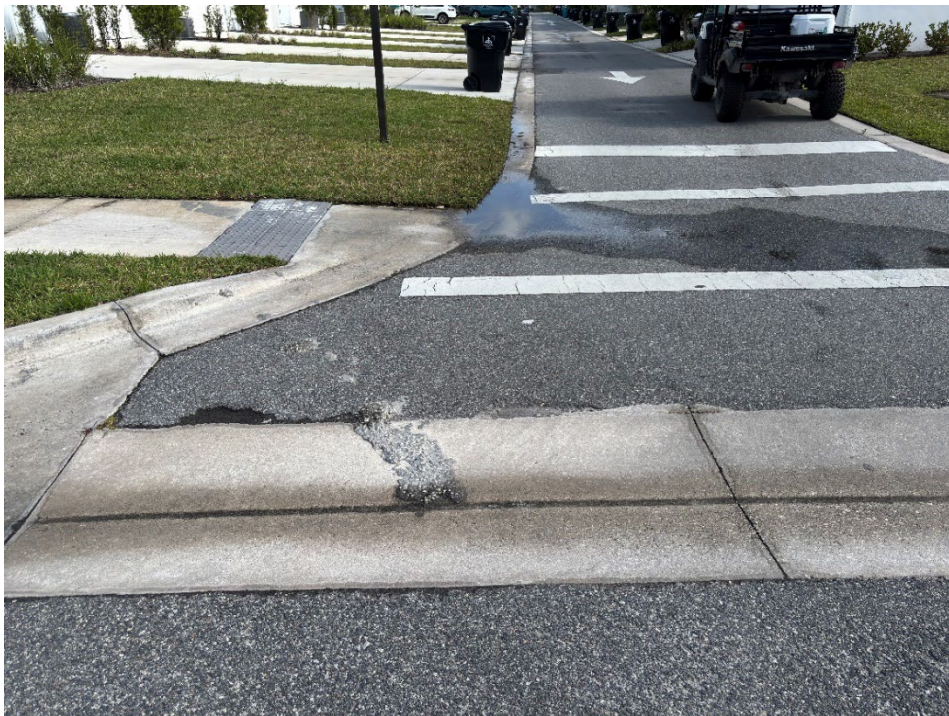
**Photo 16.1 - Bragg Alley – Low Spot in Ribbon Curb, Concrete on Valley Gutter  
(New Photo – 2026 Assessment)**

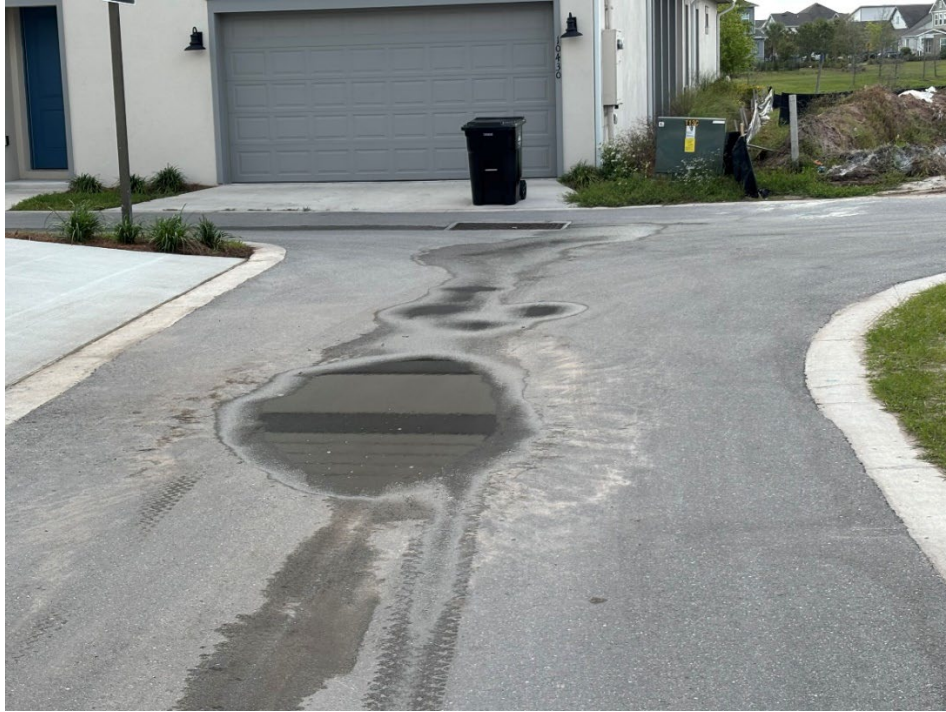
**Photo 17 - Rostand Alley – Low Spot In Valley  
(New Alley - New Photo – 2026 Assessment)**

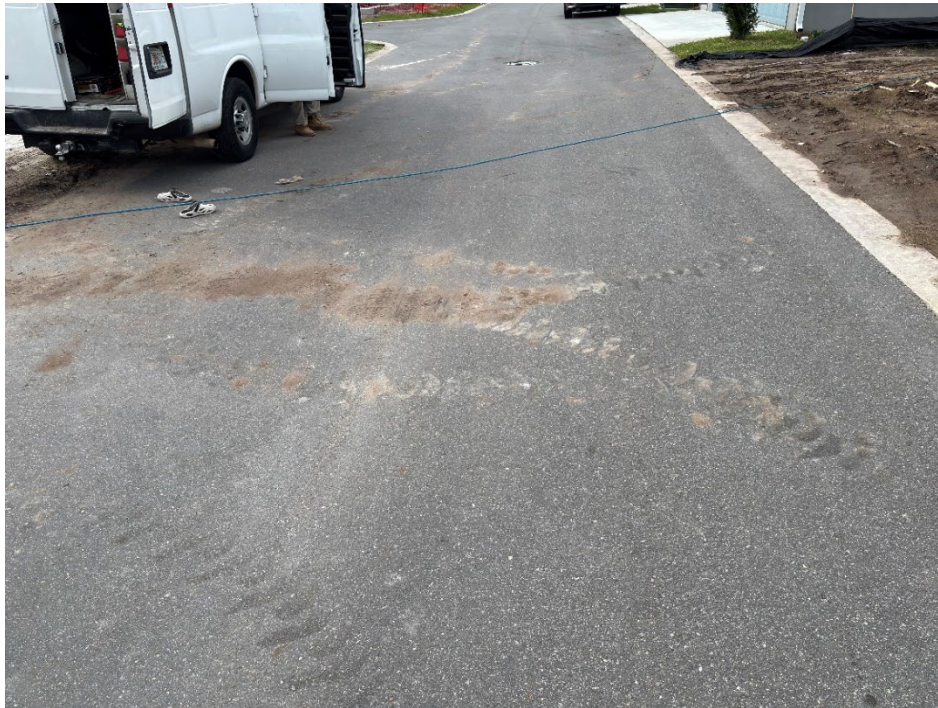
**Photo 18 - Fiddley Alley – Asphalt Damage  
(New Alley - New Photo – 2026 Assessment)**

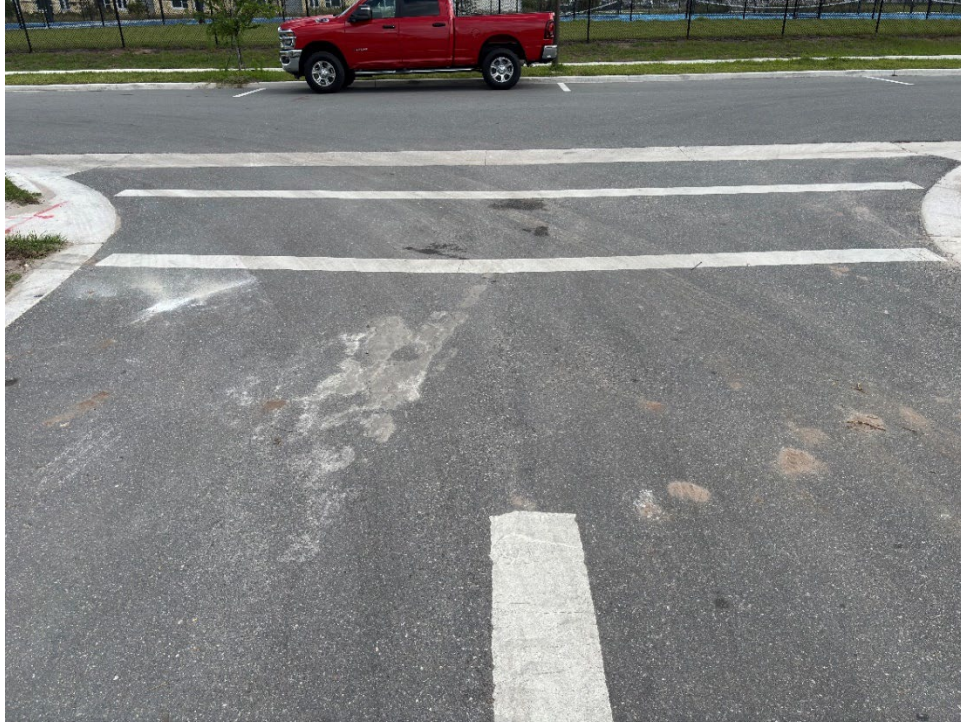
**Photo 19 - Fiddley Alley – Concrete Spilled into Asphalt  
(New Alley - New Photo – 2026 Assessment)**

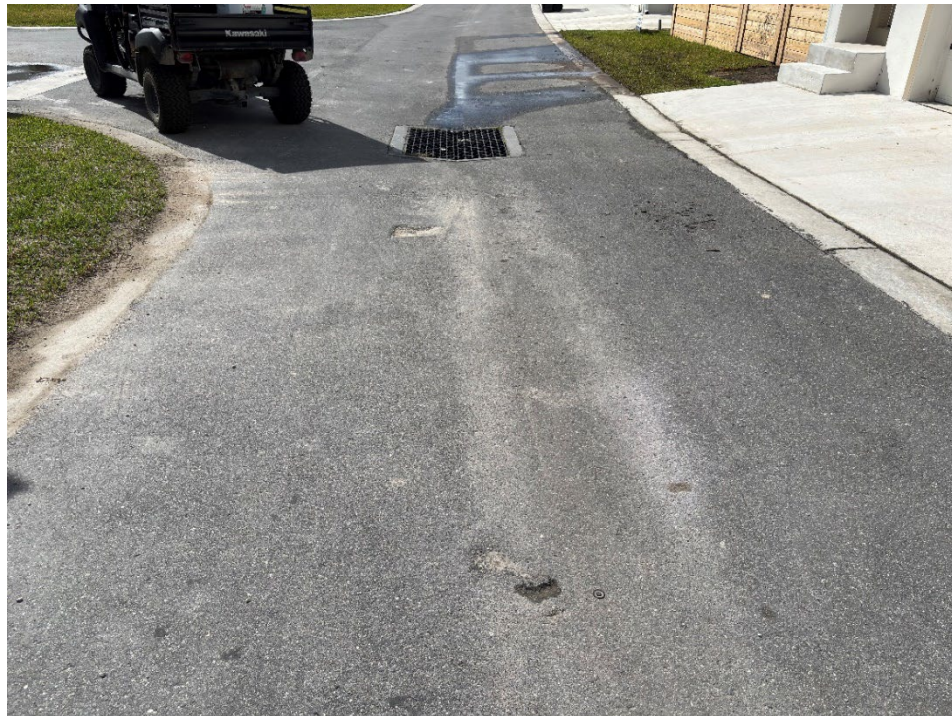
**Photo 20 - Gobat Alley – Asphalt Damage  
(New Alley - New Photo – 2026 Assessment)**

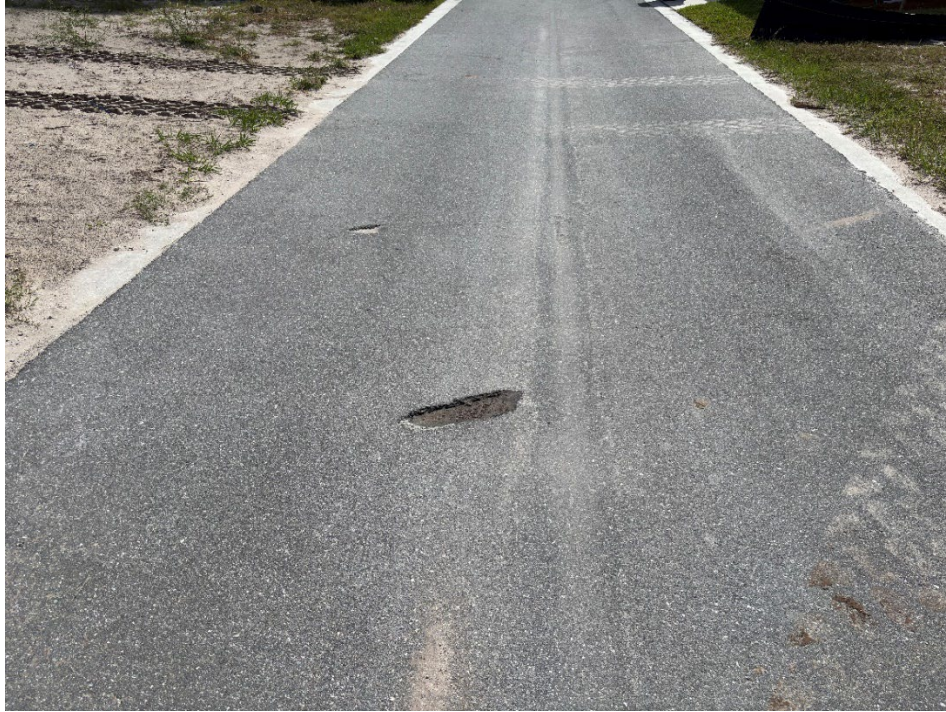
**Photo 21 - Hasselmann Alley – Asphalt Damage  
(New Alley - New Photo – 2026 Assessment)**

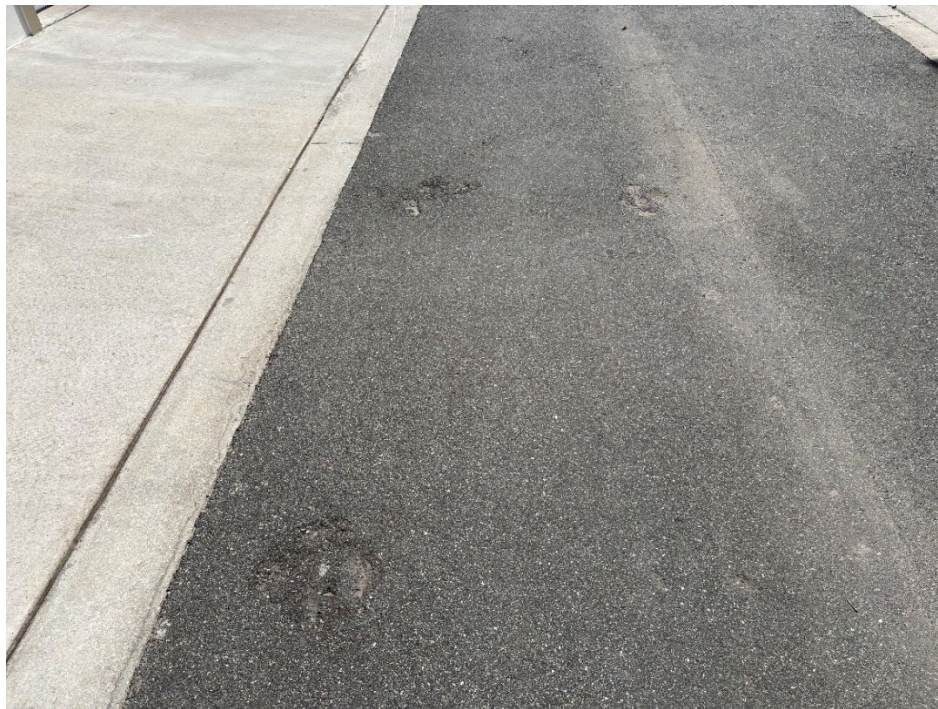
**Photo 22 - Ganzel Alley – Asphalt Raveling  
(New Alley - New Photo – 2026 Assessment)**
