# **DISTRICT INFRASTRUCTURE ASSESSMENT REPORT**

## **POITRAS EAST COMMUNITY DEVELOPMENT DISTRICT**

**APRIL 30, 2026**

**McINTOSH ASSOCIATES, an LJA COMPANY  
1950 SUMMIT PARK DRIVE, SUITE 600  
ORLANDO, FL 32810**

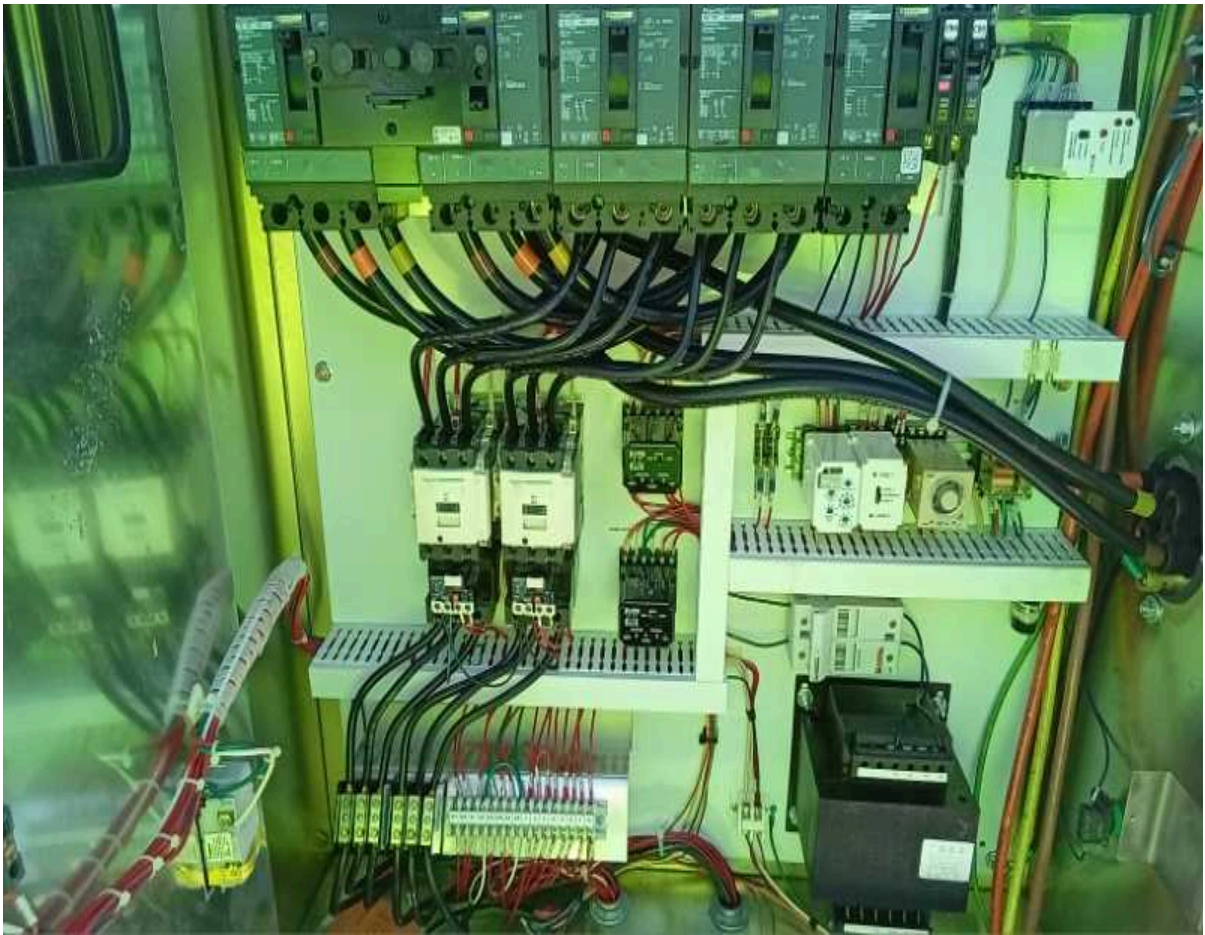
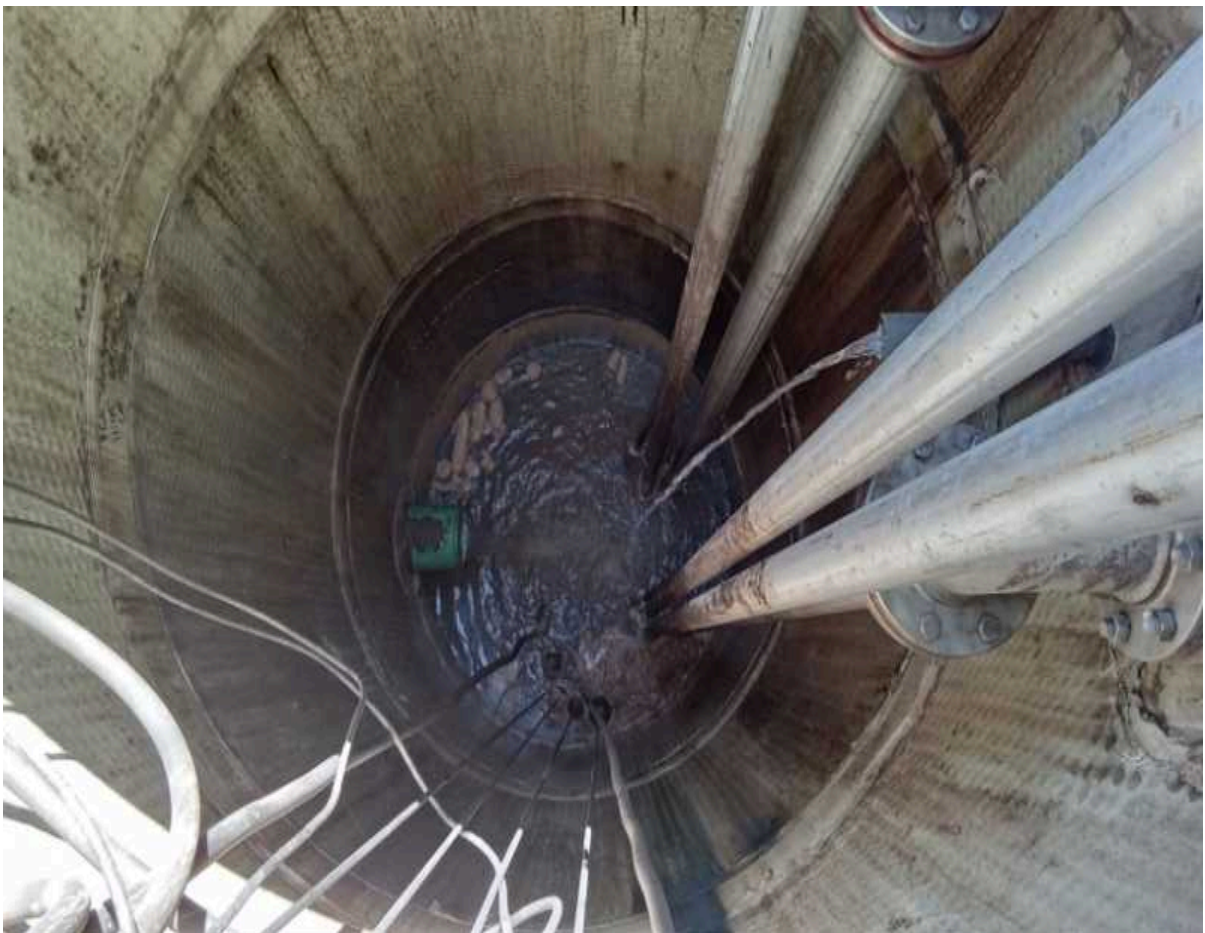
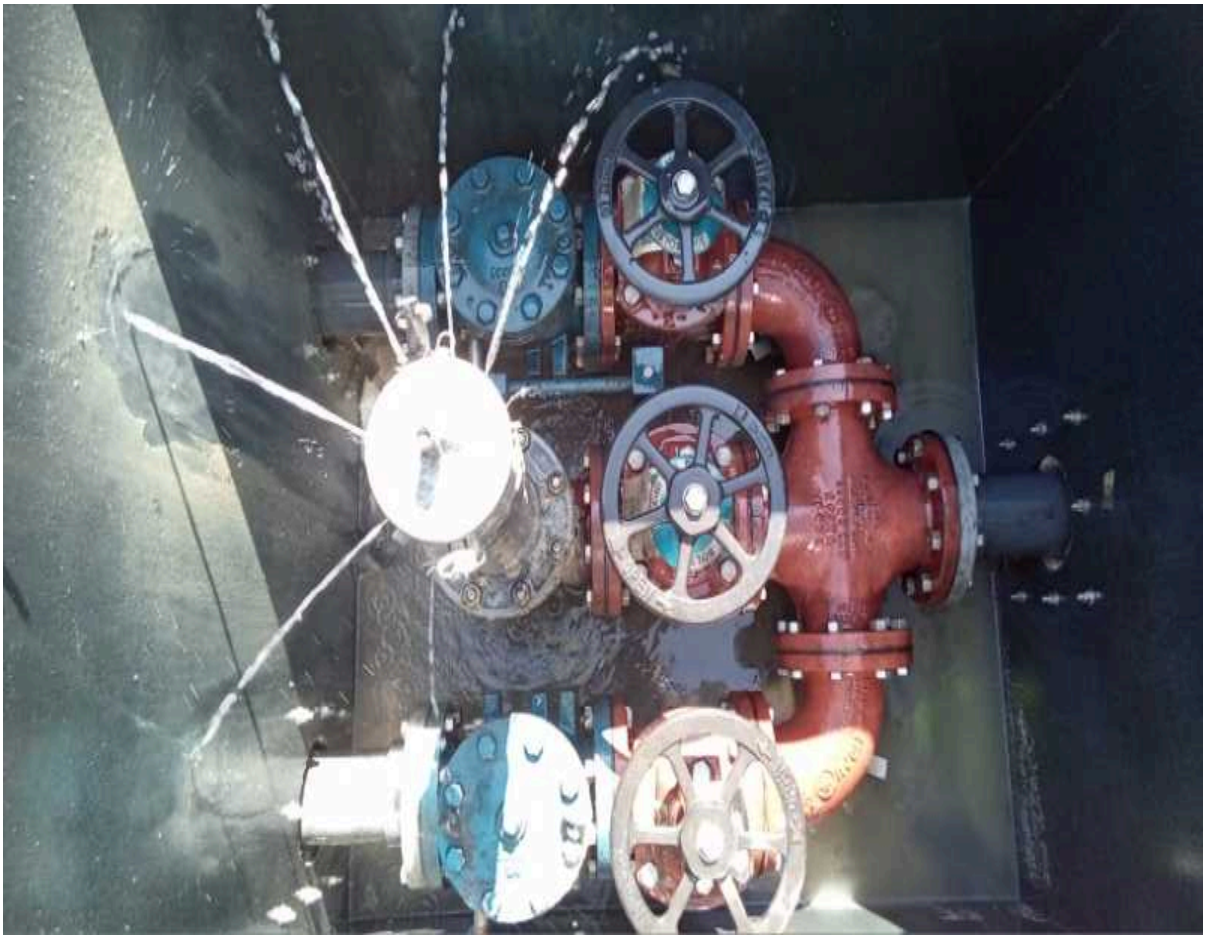
Cover was accessed and properly secured. Performed a Lift Station inspection. Work performed today included: Inspection of wet well and valve box and control panel and ran station through a complete cycle to insure that the station is working as it should. Recommend Eval/Custom Cleaning. Alarm beacon is not working.

- Recommend Eval/Custom Cleaning.

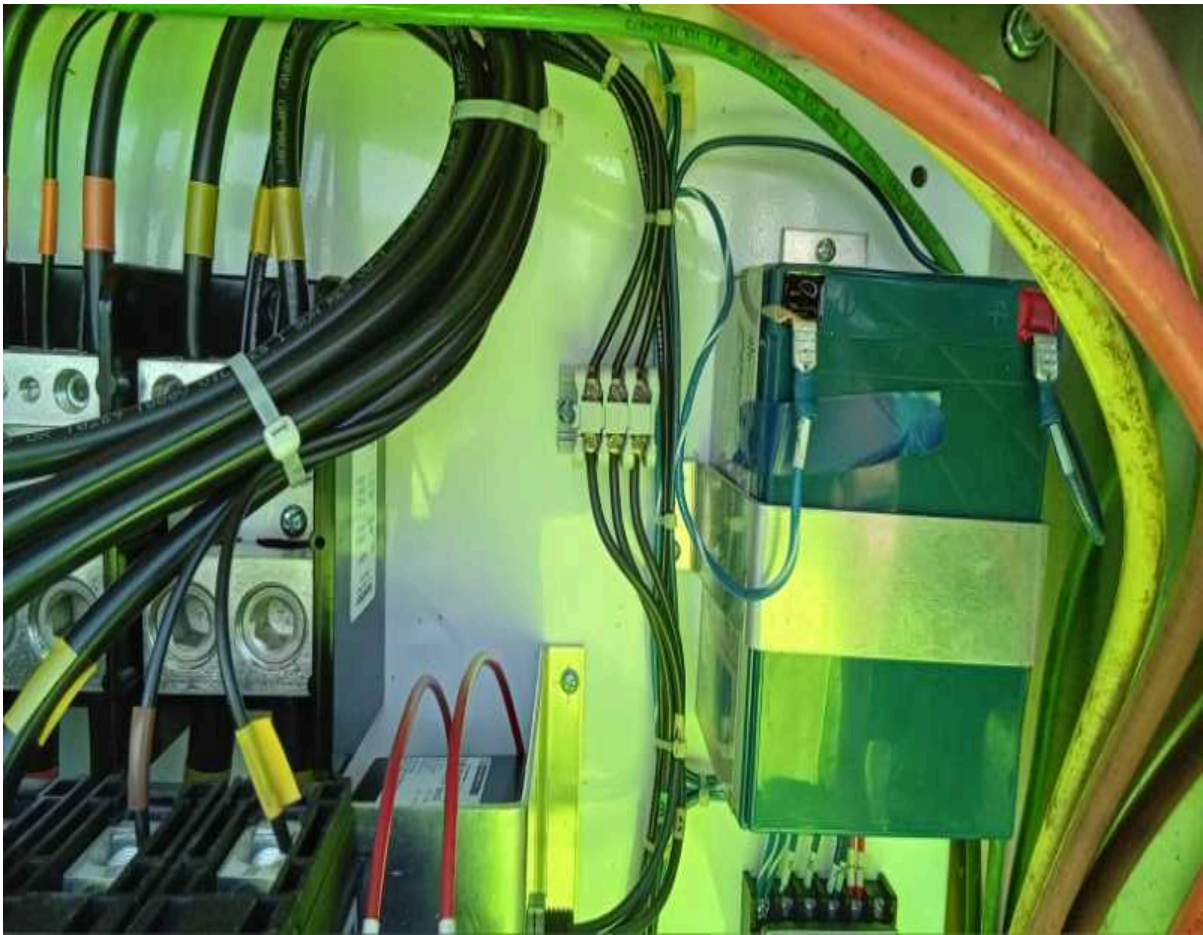
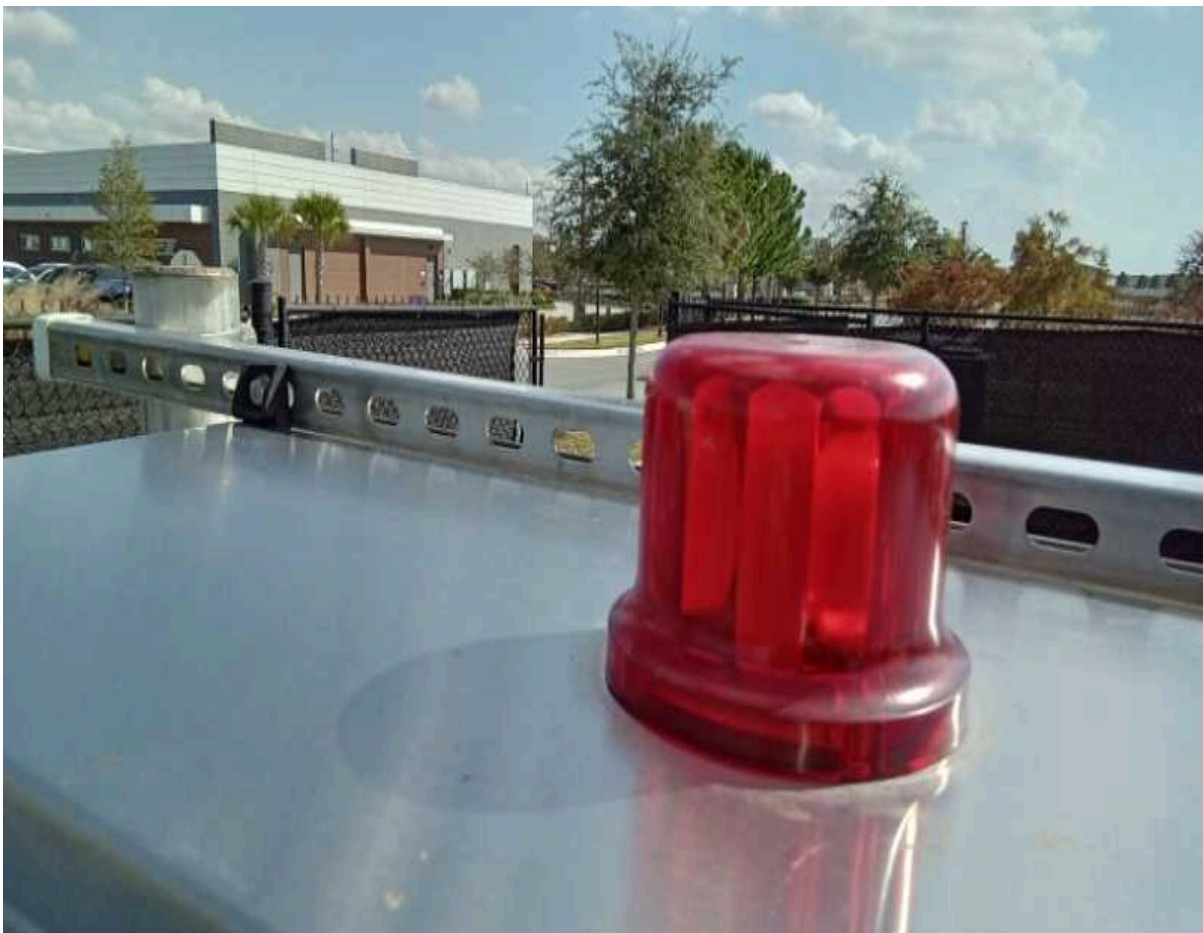
Cover was accessed and properly secured. Work performed today included: Met with customer and went over the issues found at the station. Recommend Eval/Custom Cleaning. Need a battery for emergency back up and new alarm beacon and new emergency service sign.

- Recommend Eval/Custom Cleaning.

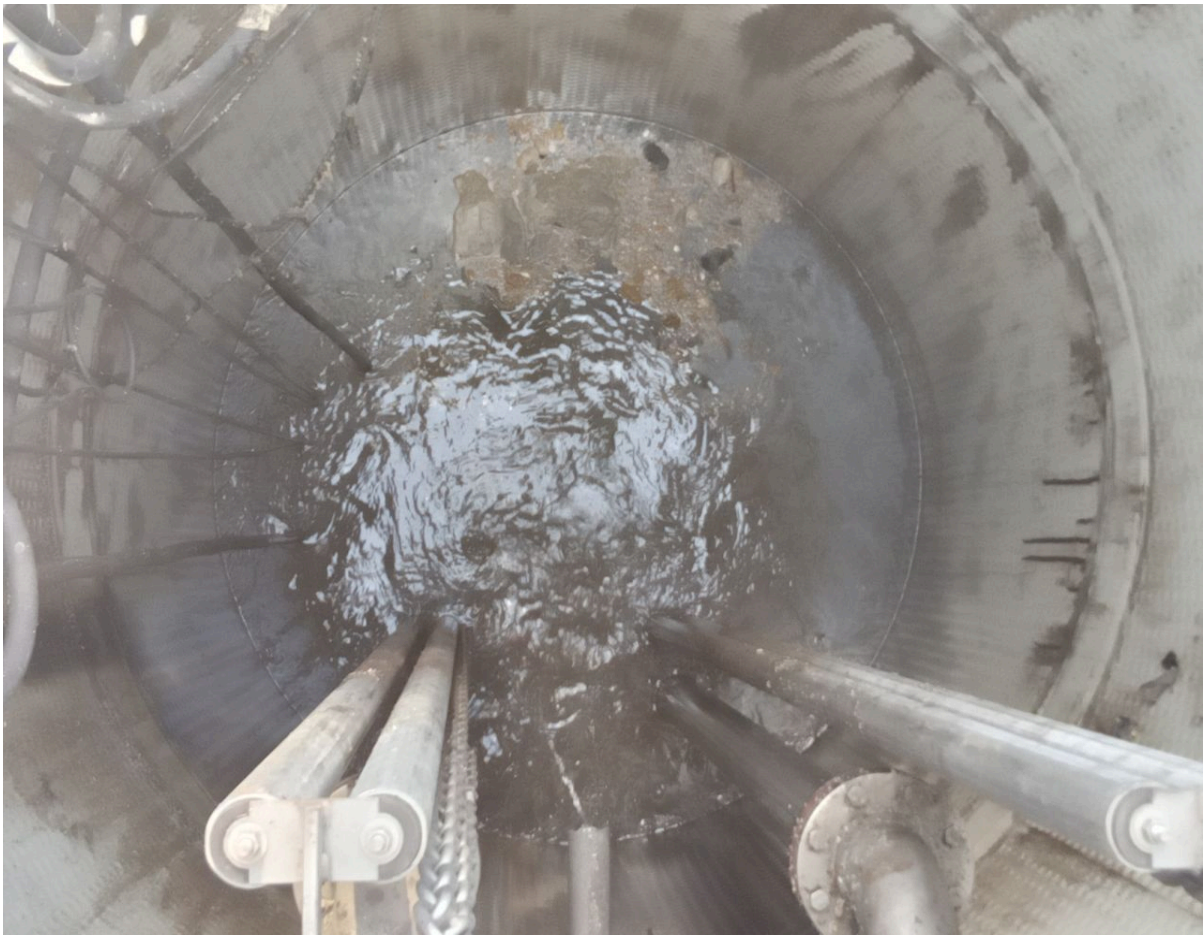
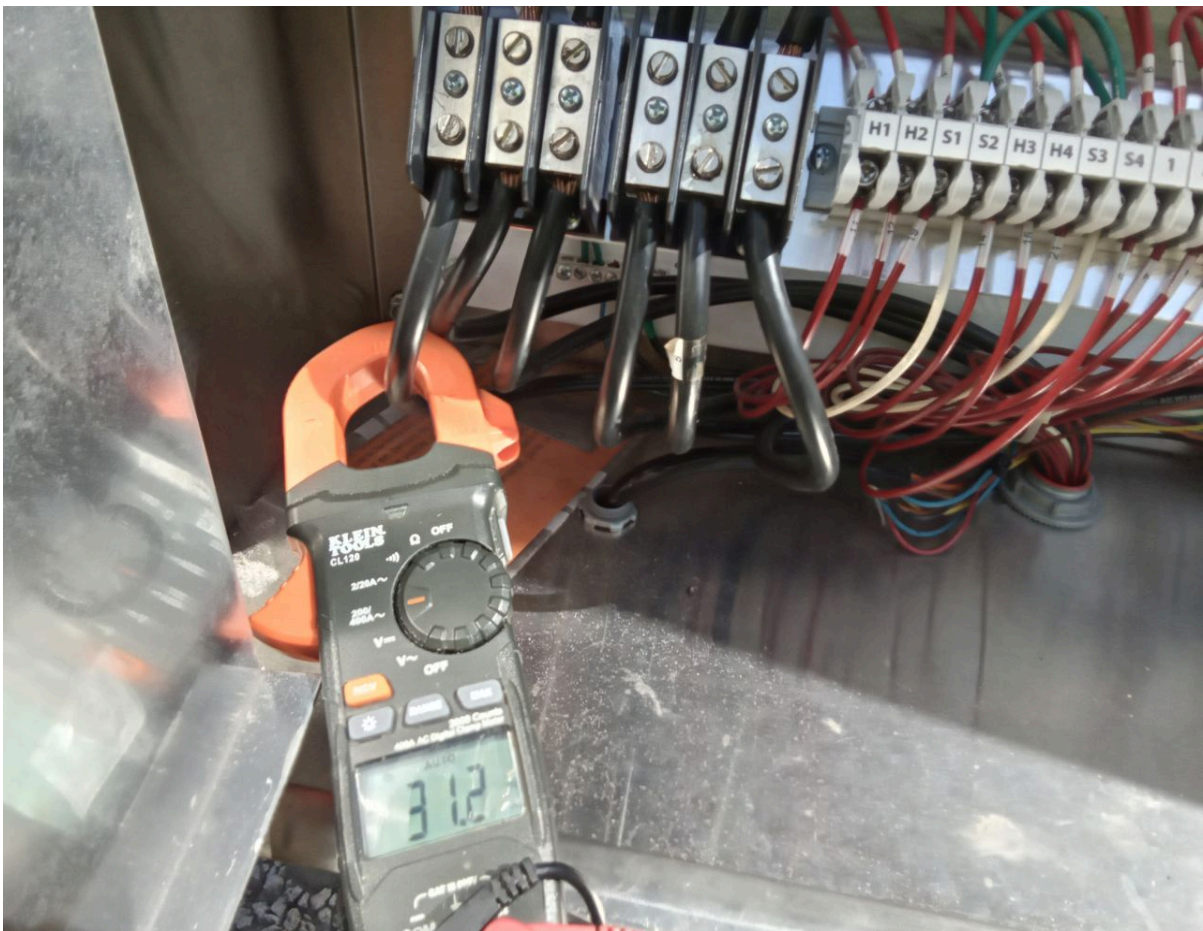
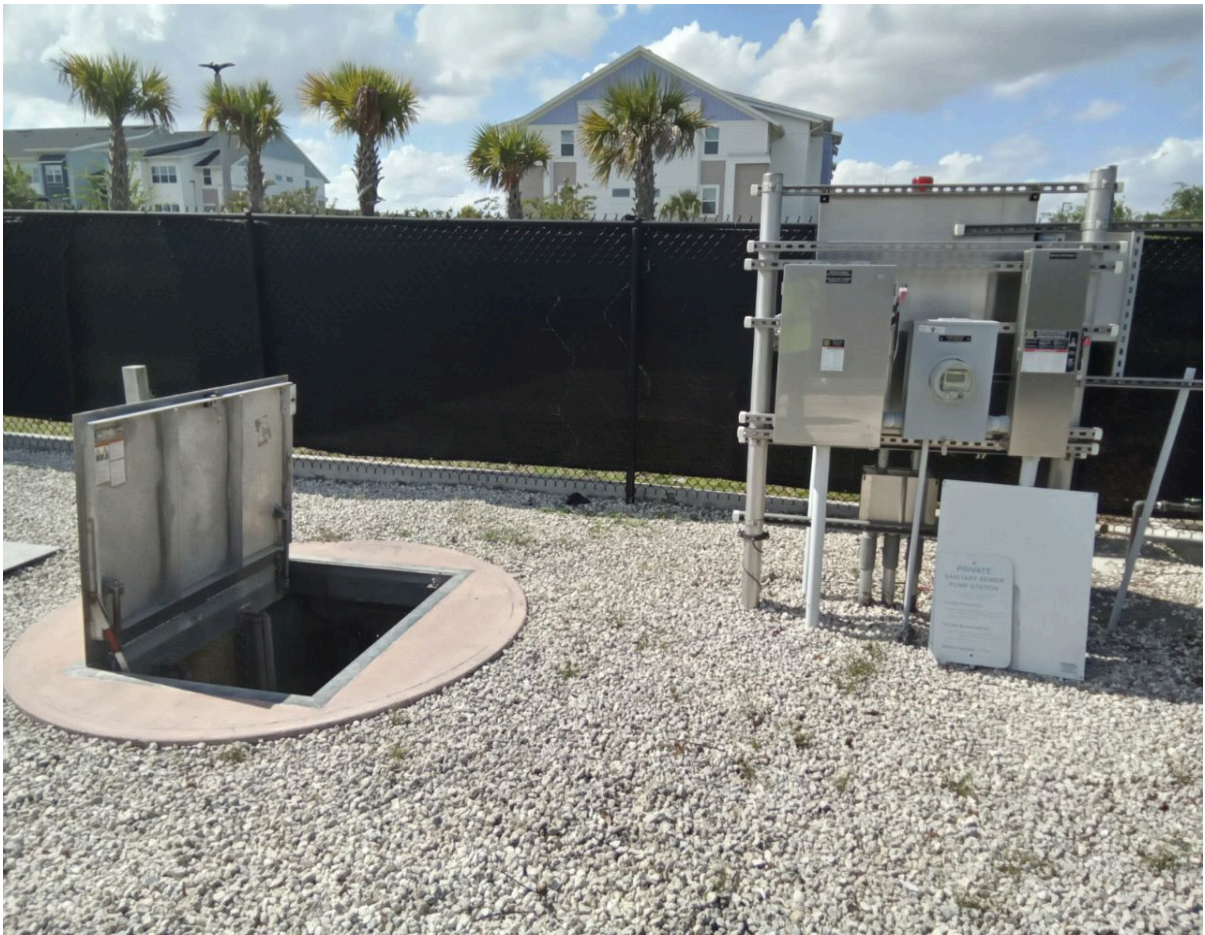
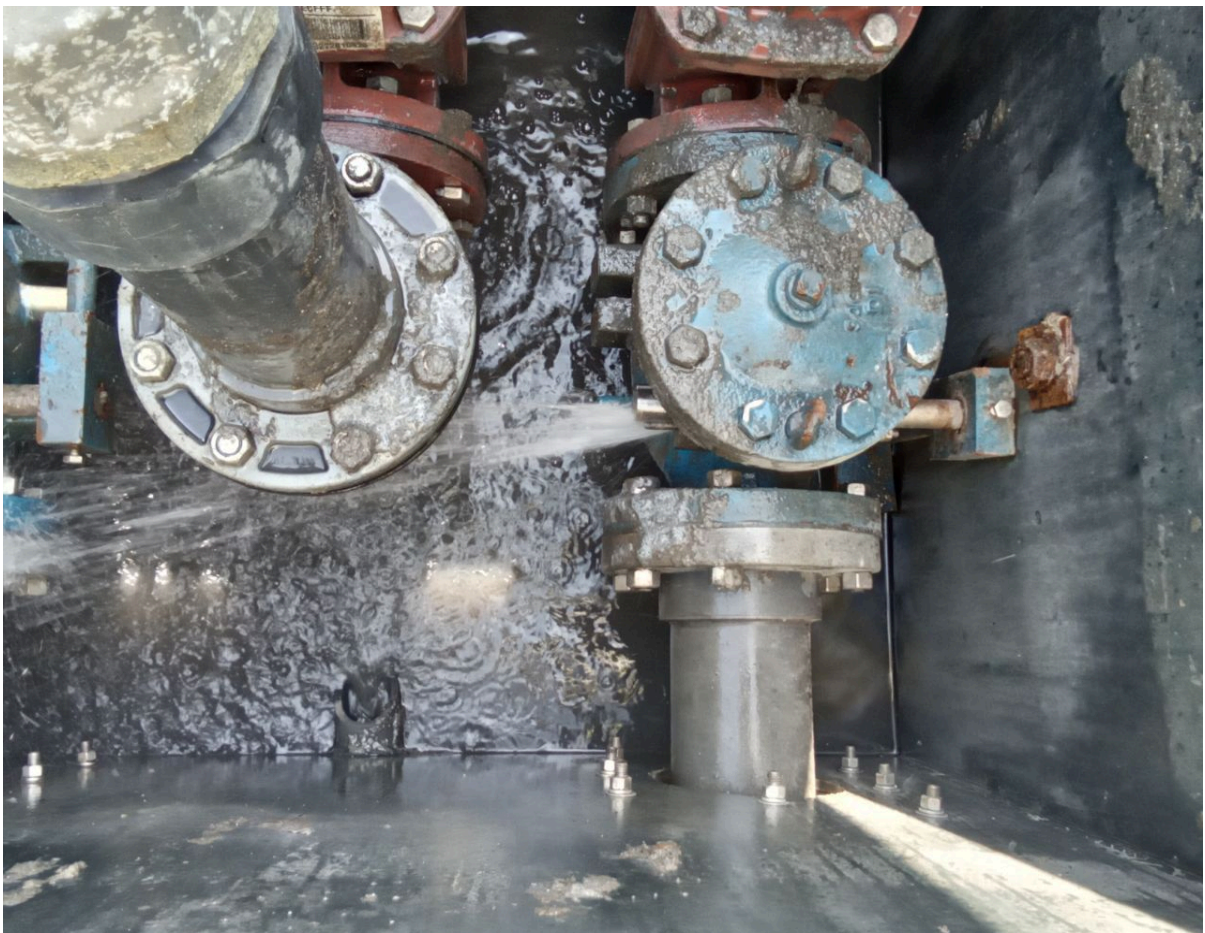
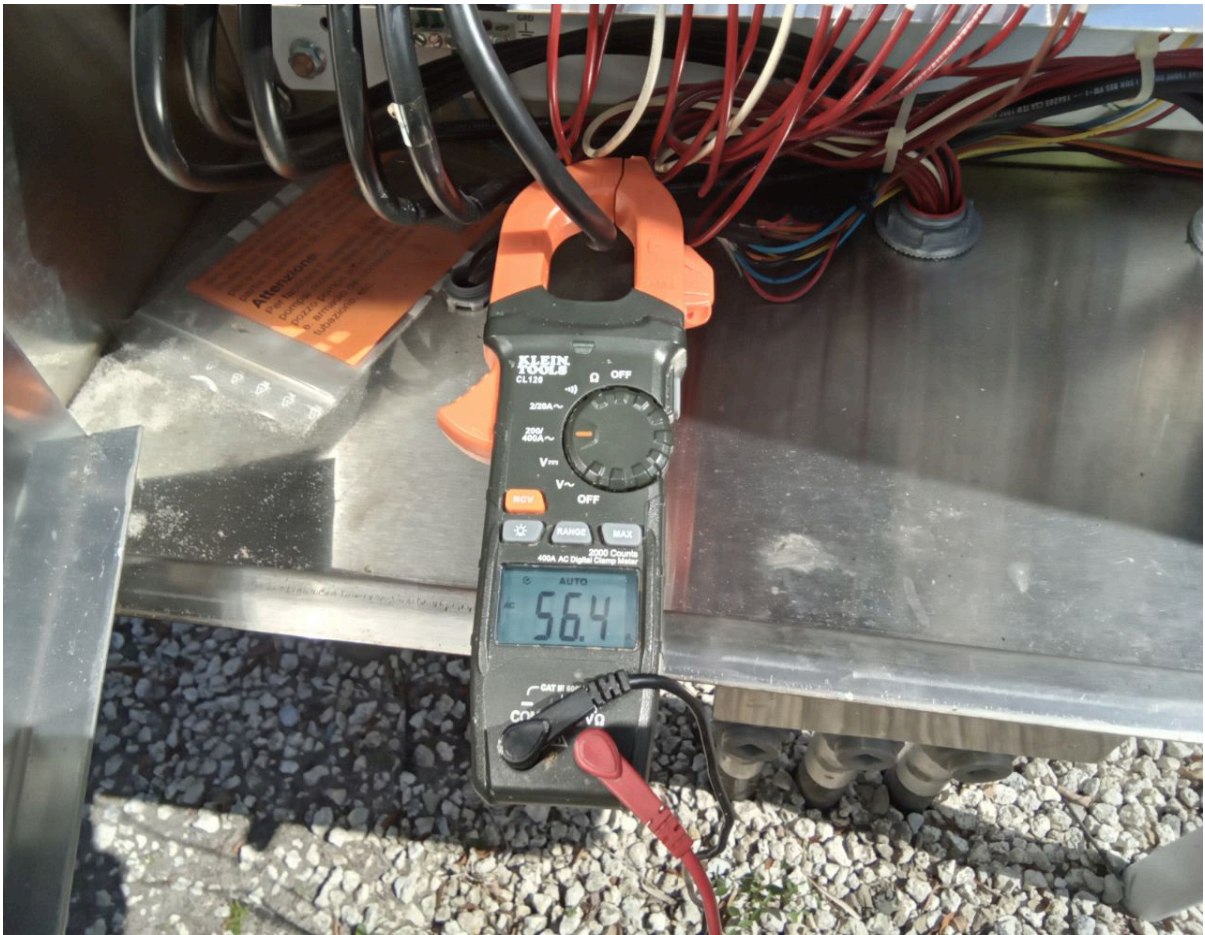
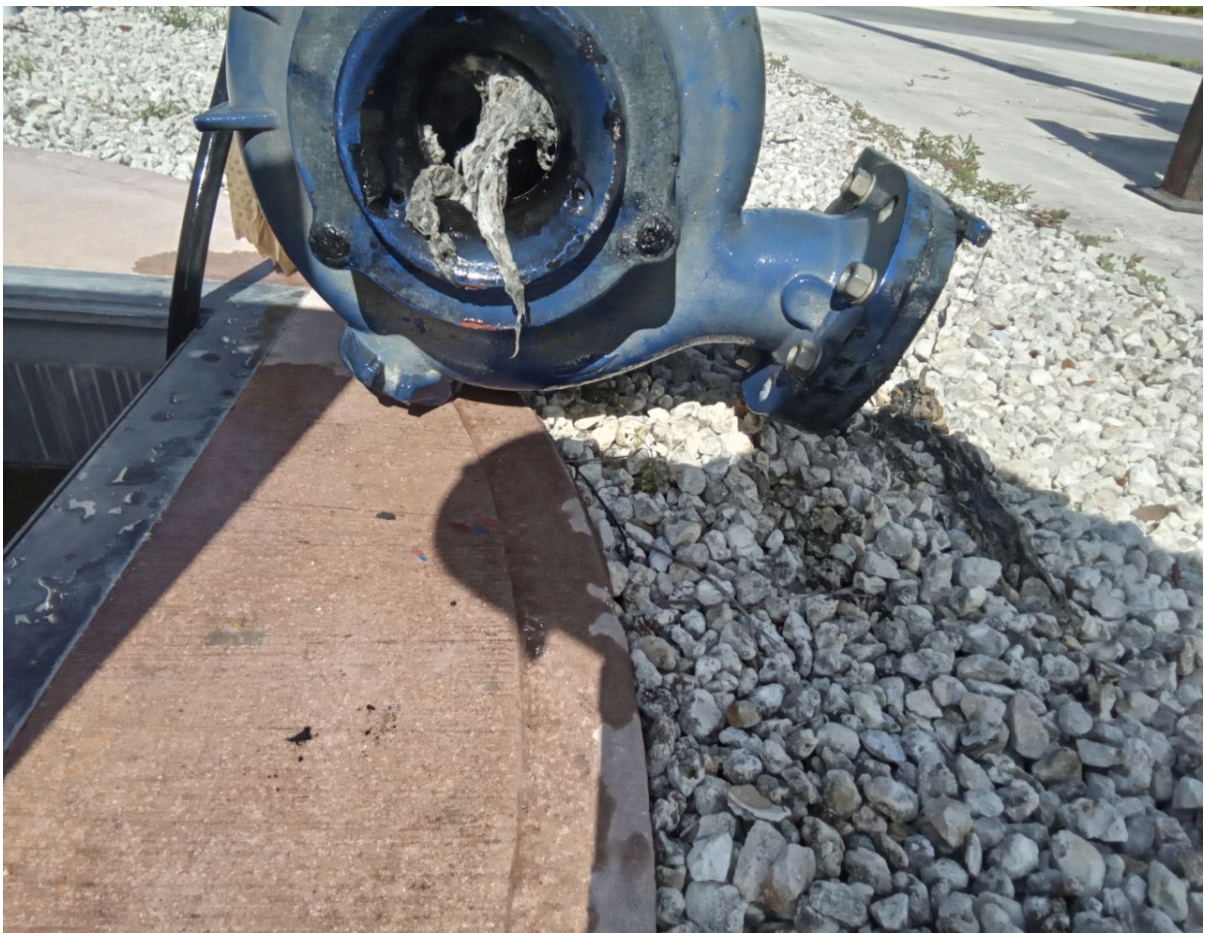
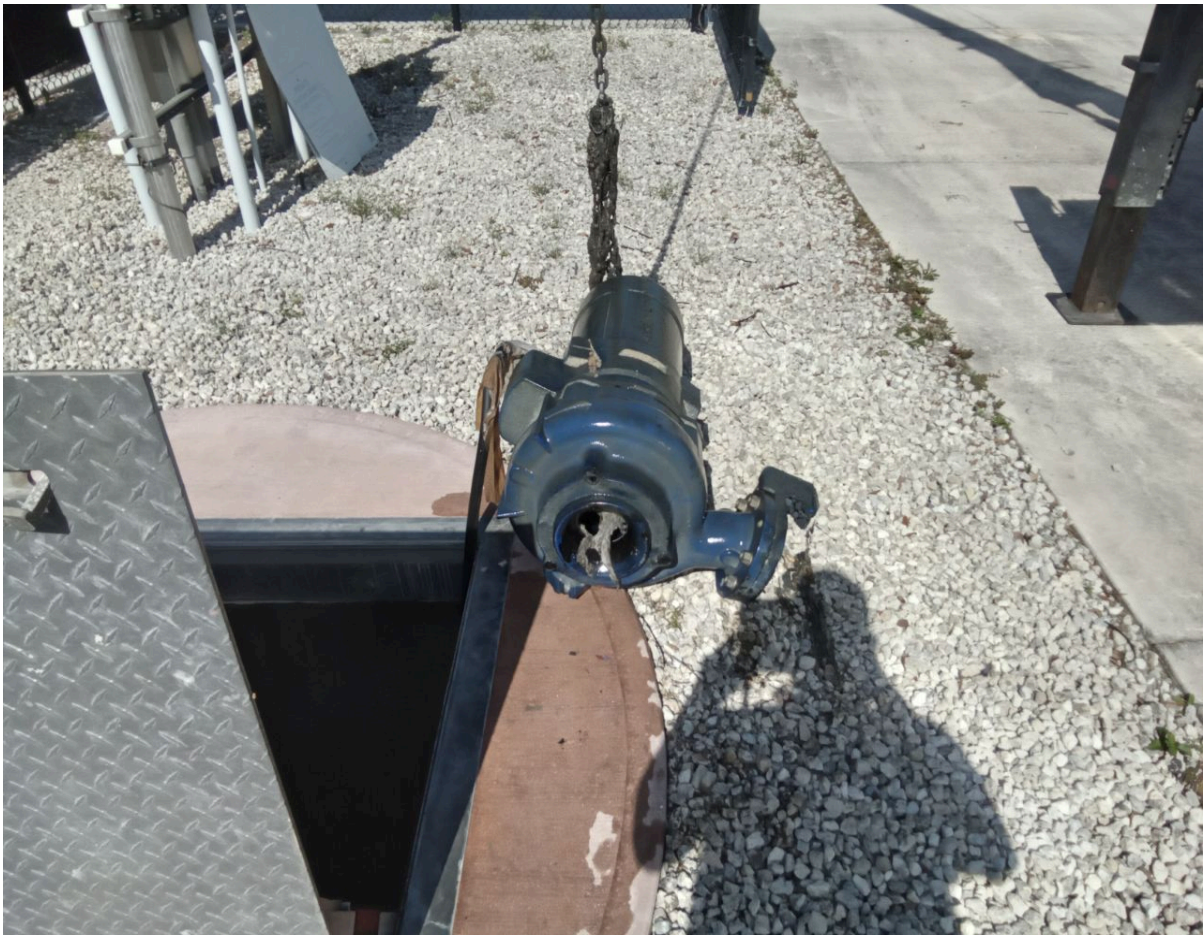
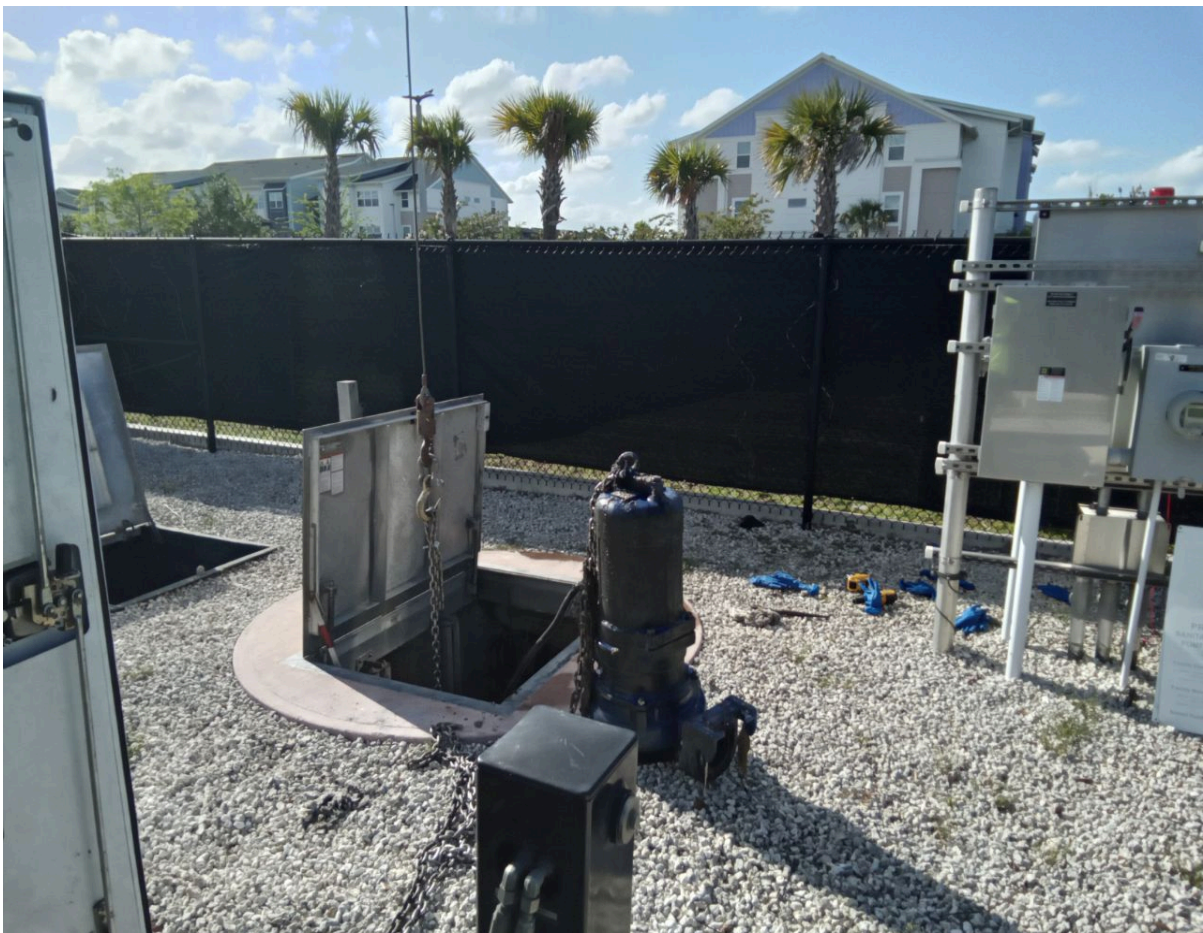
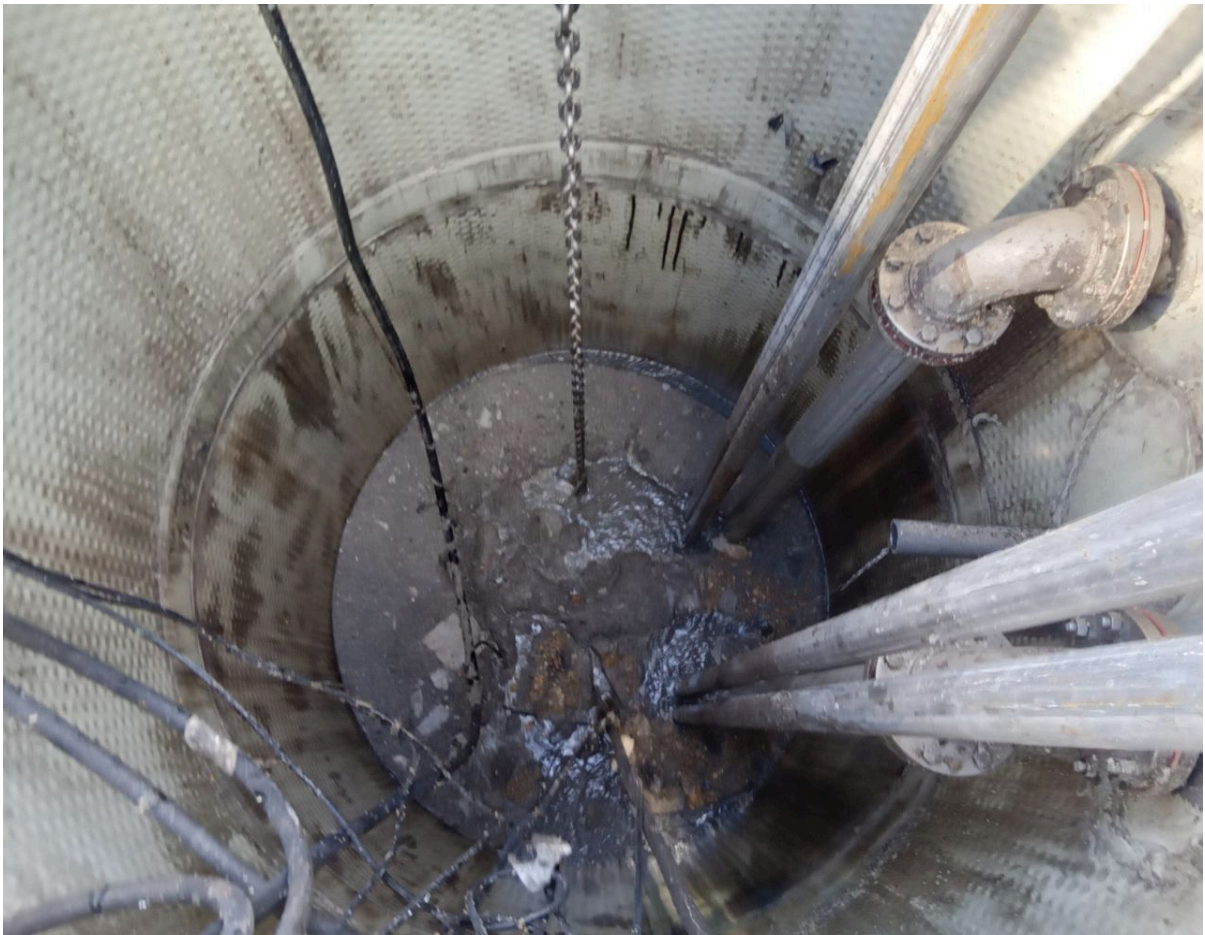
Cover was accessed and properly secured. Work performed today included: Arrived at station for emergency call. Upon arrival I noticed that pump 1 4inch check valve was bad , stop pump 1 from pumping, pump 2 have a bad overload making it keep tripping at 44amp , so to make it work until it gets fixed, I put pump 1 on pump 2 side so station will pump down in auto. Recommend 1 new 4inch check valves, 1new overload. Station is operating with 1 pump in auto. Arrived at station for emergency call. Upon arrival I noticed that pump 1 4inch check valve was bad , stop pump 1 from pumping, pump 2 have a bad overload making it keep tripping at 44amp , so to make it work until it gets fixed, I put pump 1 on pump 2 side so station will pump down in auto. Recommend 1 new 4inch check valves, 1new overload. Station is operating with 1 pump in auto. Recommend Lift Station/Pump Repairs.

- Recommend Lift Station/Pump Repairs.
